# TOWN OF BRATTLEBORO

To: Brattleboro Selectboard  
Via: Peter B. Elwell, Town Manager  
From: Patrick Moreland, Assistant Town Manager  
Re: Handicapped Parking on West Side of Main Street

TO: Selectboard  
VIA: Peter Elwell, Town Manager  
FROM: Sue Fillion, Planning Director  
DATE: January 3, 2020  
RE: VT Outdoor Recreation Collaborative Community Grant 2019-20

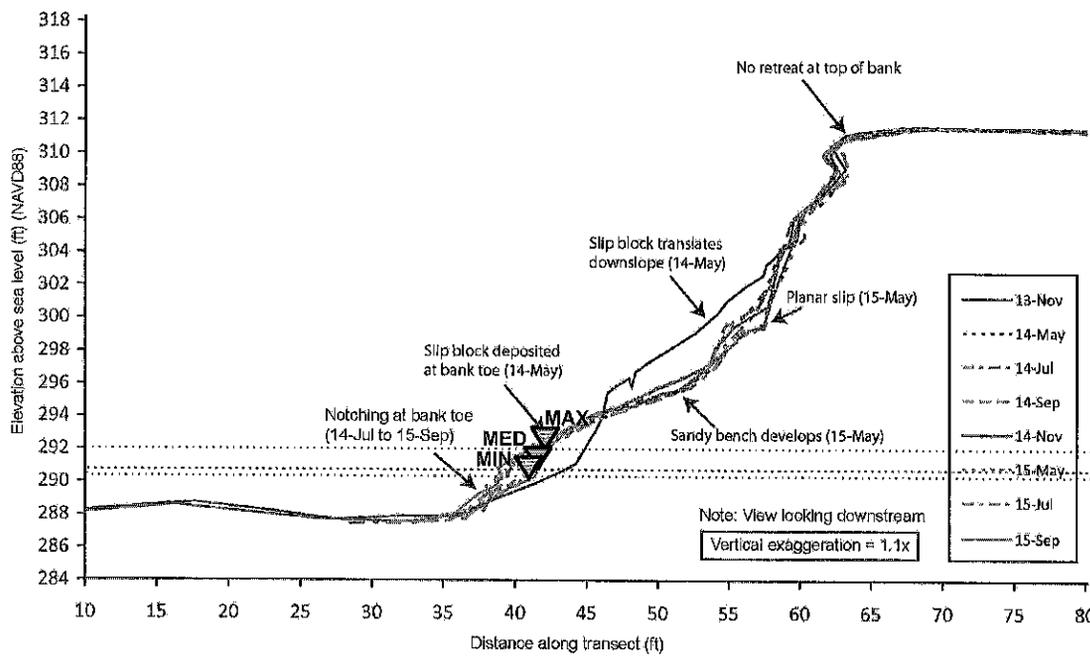
Erosion monitoring transect for 02-B03 (Jarvis Island Site).

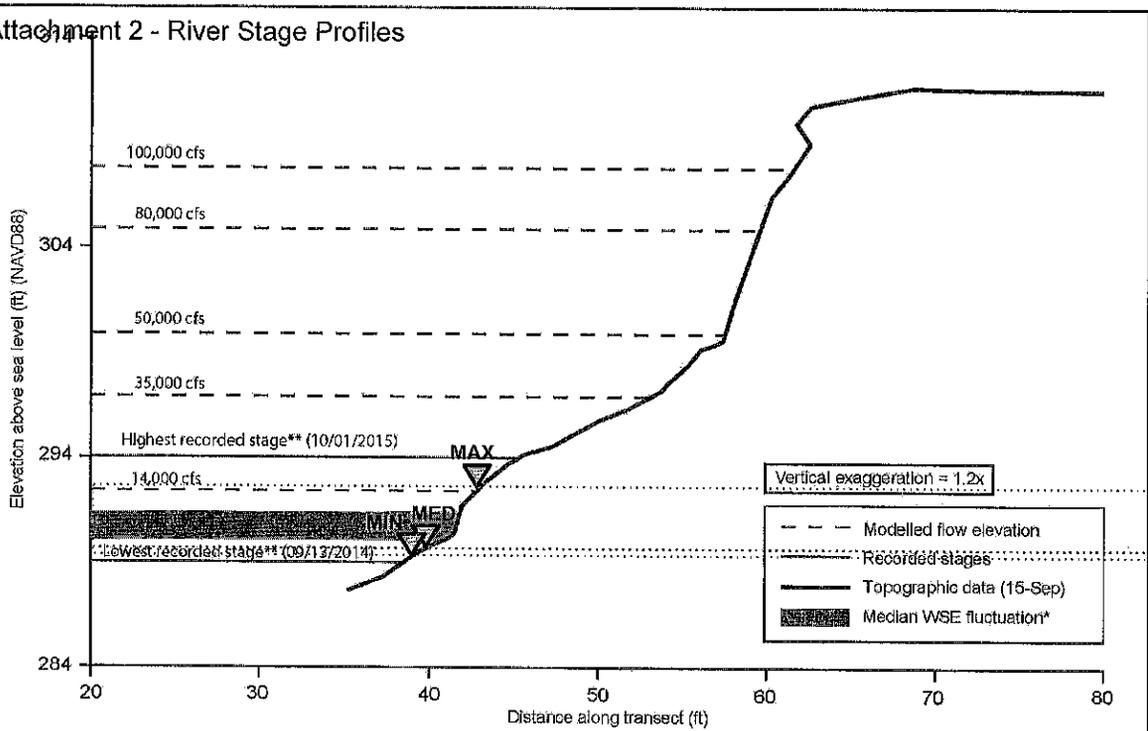
\*Note: Median WSE fluctuation at site equals 4.5 feet under no-spill conditions  
 \*\*Note: Flow stage recorded at site from 06/2014 - 11/2014 and 07/2015 - 11/2015

Selected river stages at 02-B03 (Jarvis Island Site).

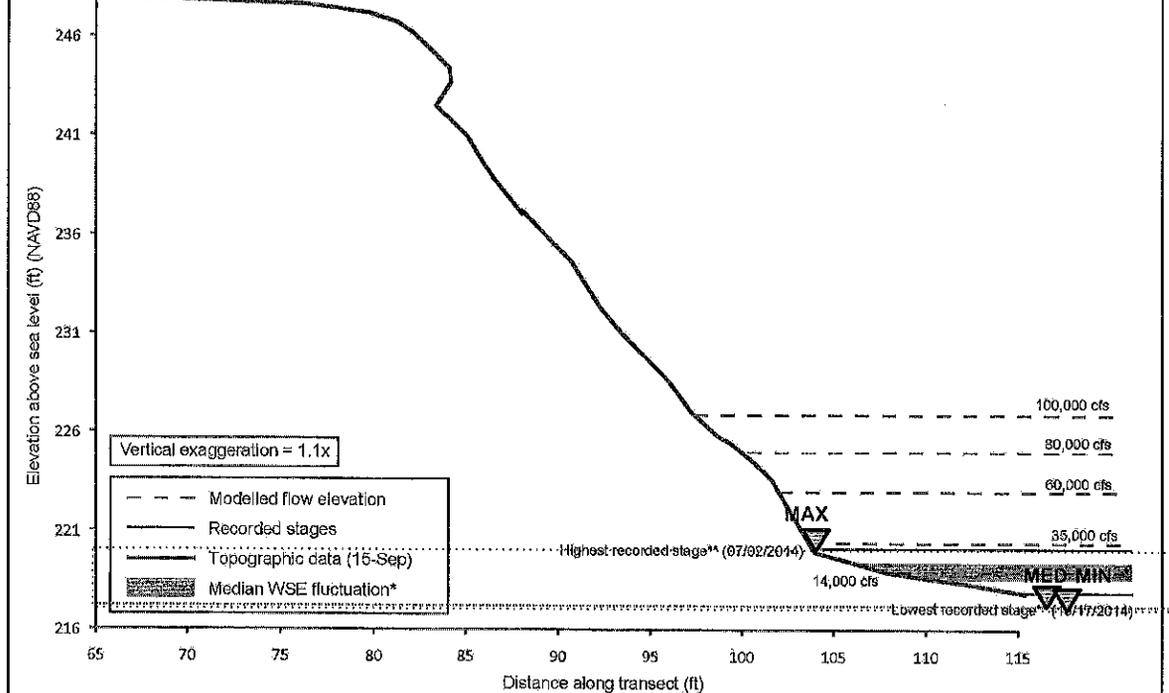
\*Note: Median WSE fluctuation at site equals 0.9 feet under no-spill conditions  
 \*\*Note: Flow stage recorded at site from 08/2014 - 11/2014 and 07/2015 - 11/2015

Selected river stages at 02-V06 (LaCroix Site).

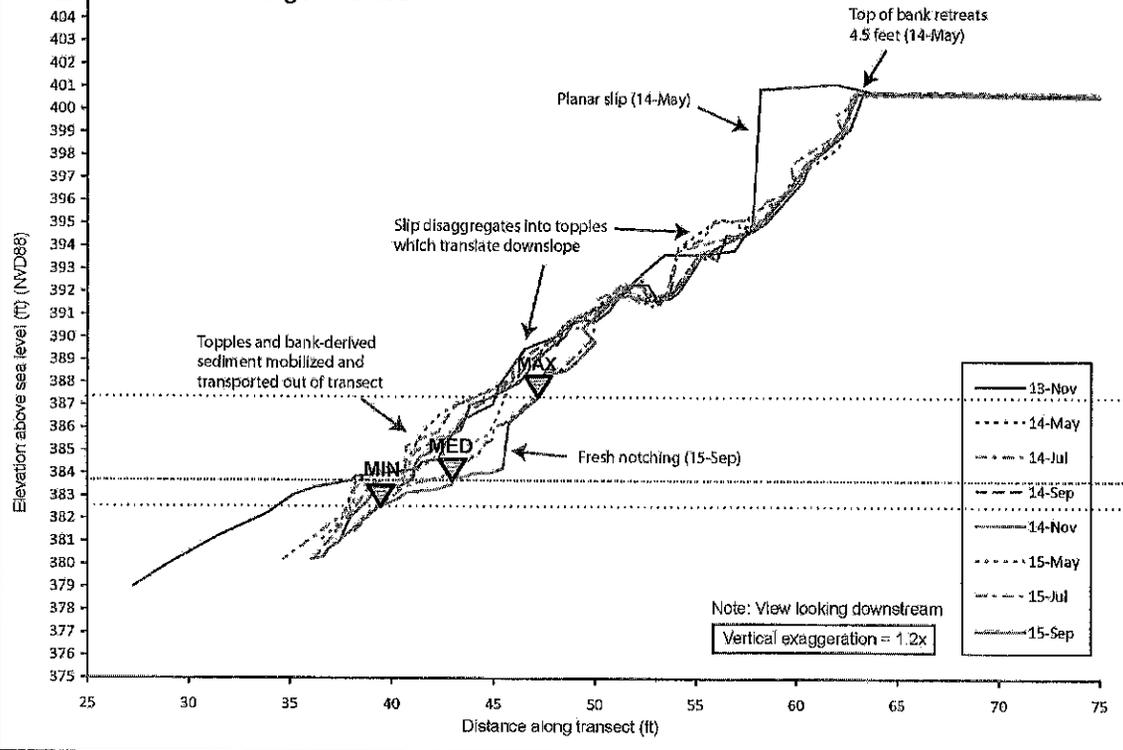
Erosion monitoring transect for 02-W03 (Bellavance Site).

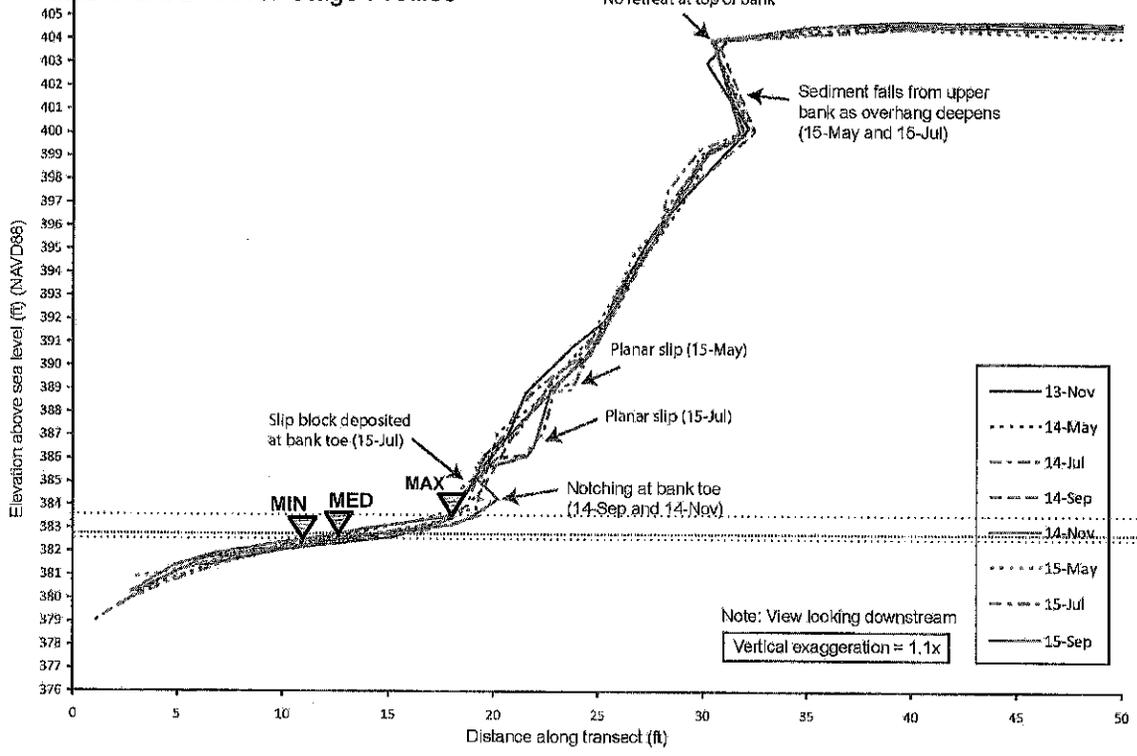
Erosion monitoring transect for 02-W10 (Vaughn Site).

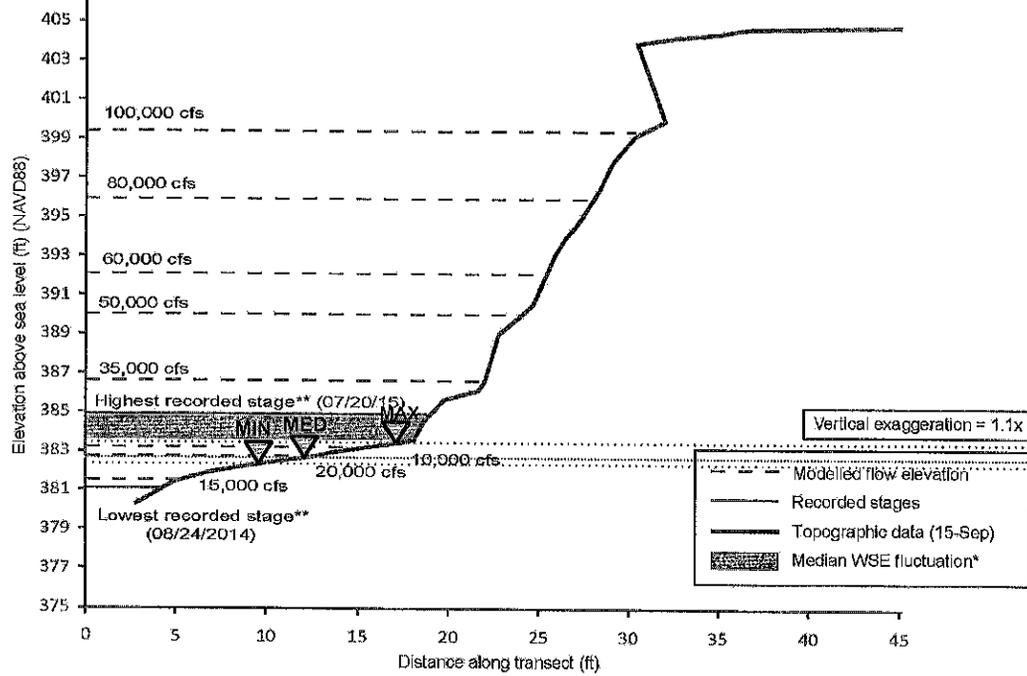
\*Note: Median WSE fluctuation at site equals 1.11 feet under no-spill conditions

\*\*Note: Flow stage recorded at site from 08/2014 - 11/2014 and 07/2015 - 11/2015

Selected river stages at 02-W10 (Vaughn Site).

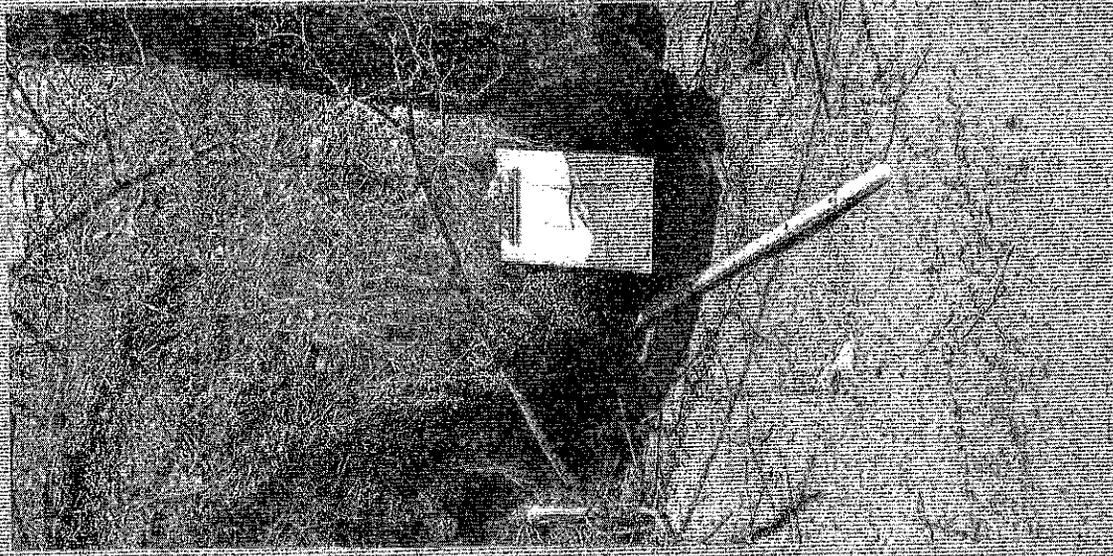
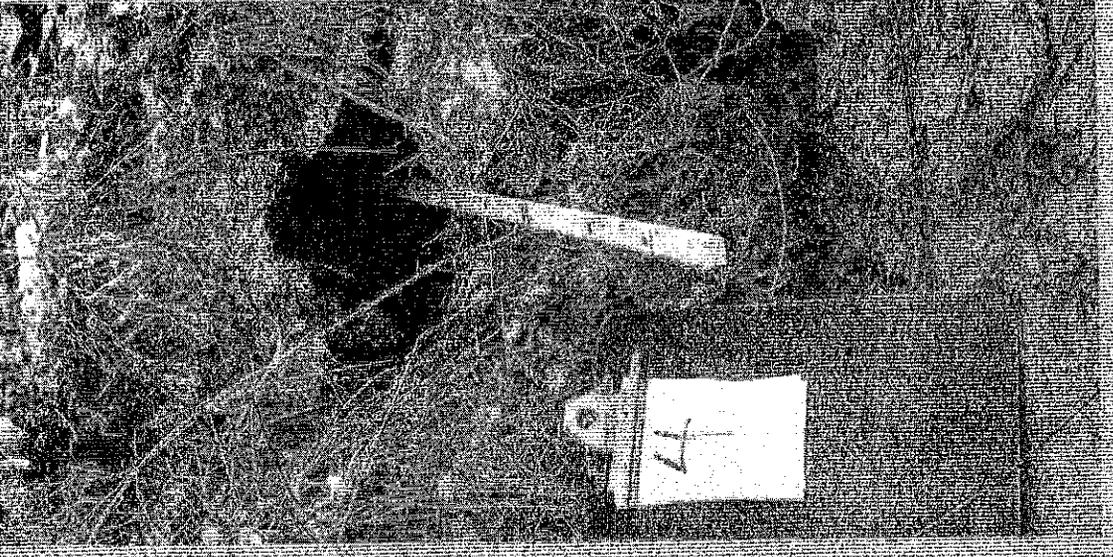
What happens? As the water level is raised, the silty and sandy soil is saturated. Then the water is lowered and seep holes are formed and soil is removed from the riverbank. Seeps can be 4-5 feet deep into the riverbank.

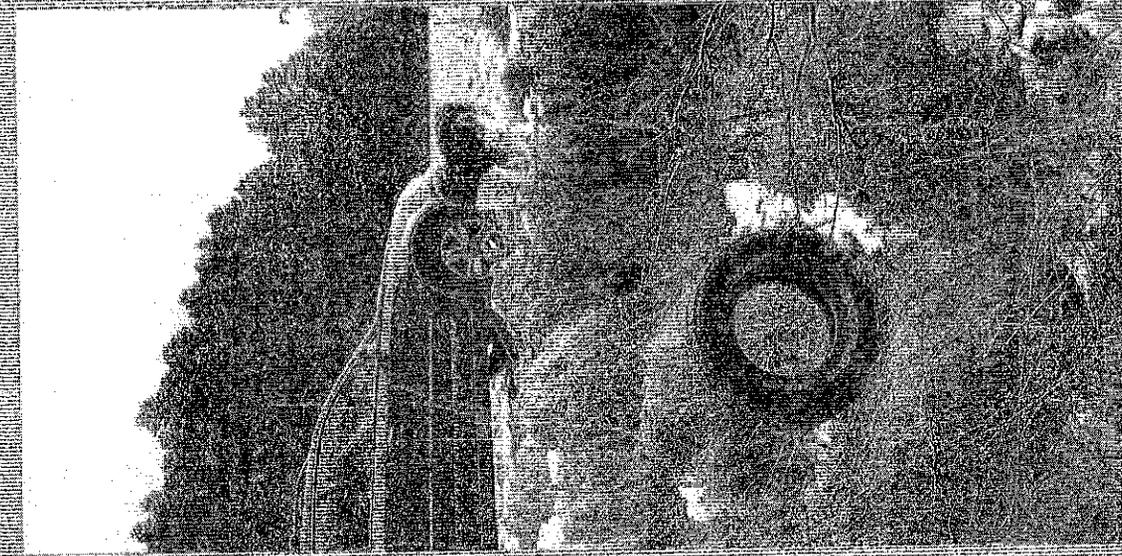
Next, the seep holes get larger and larger and in time they collapse and deep sink holes are formed and the erosion of the bank really begins. Above, sink holes 5-6 feet deep
