Above the Flood: Elevating Your Floodprone House

FEMA 347 / May 2000

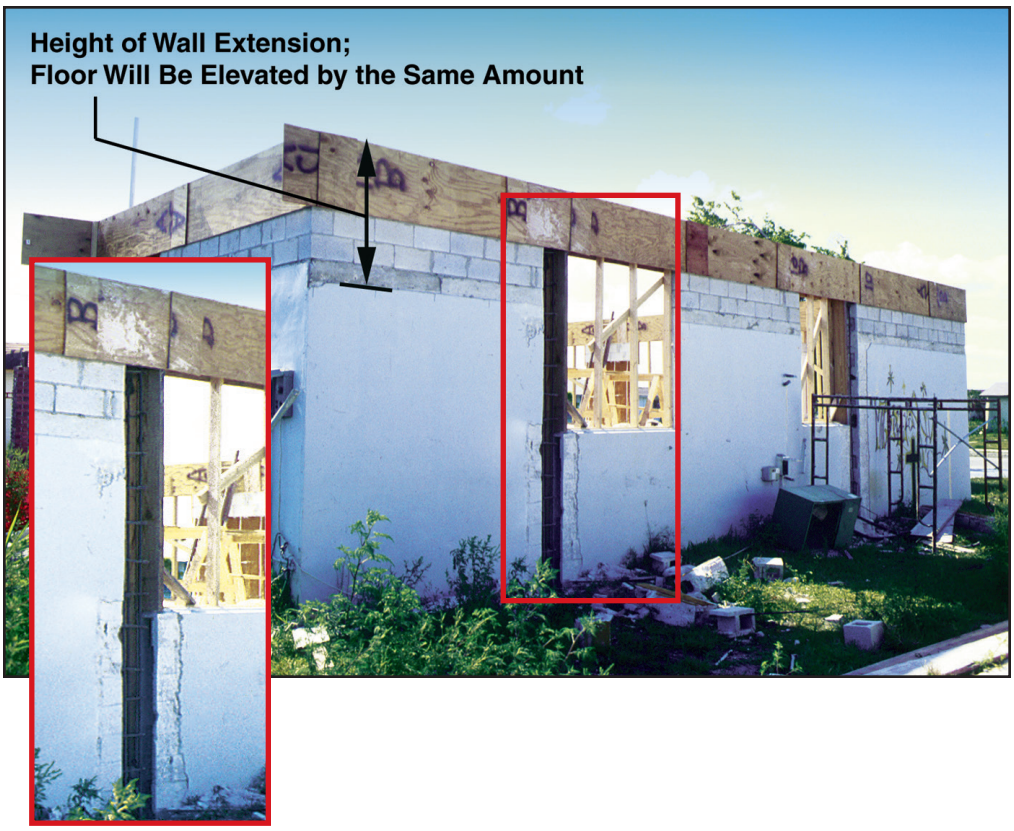
Figure 24
Another view of the extended walls. The vertical cuts in the walls next to the windows are for concrete tiedown columns that will be cast in place to further strengthen the extended walls against wind loads. The owner of this house was able to meet the elevation requirement by raising the floor only a few feet, as indicated by the amount that the walls have been extended.

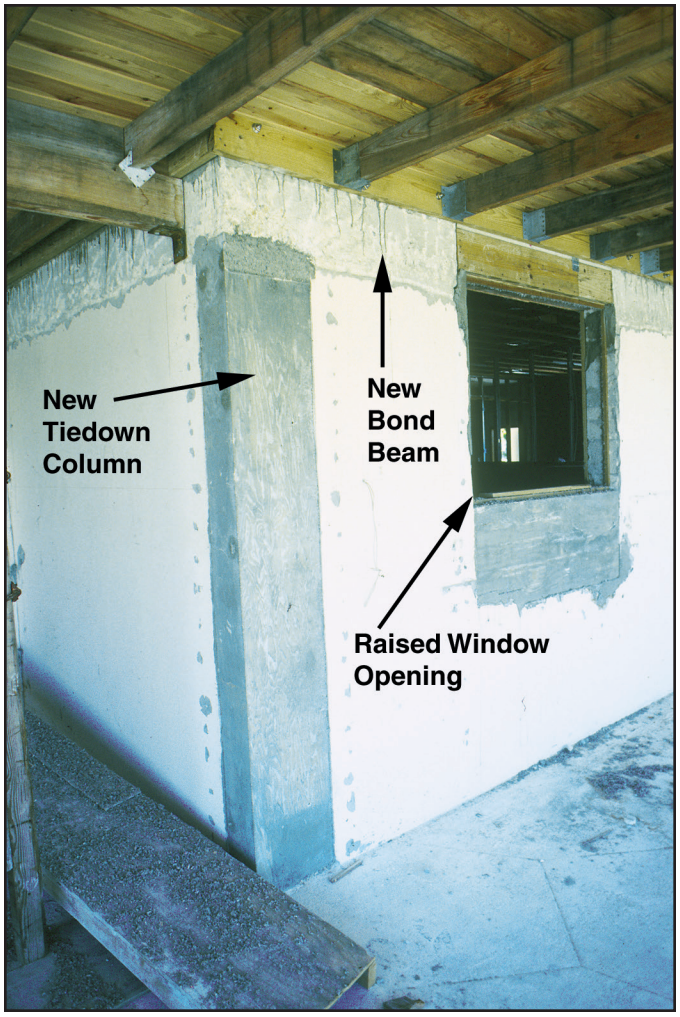
Figure 41
Note the new bond beam at the top of the extended wall, the new concrete tiedown column at the corner, and the raised window opening.

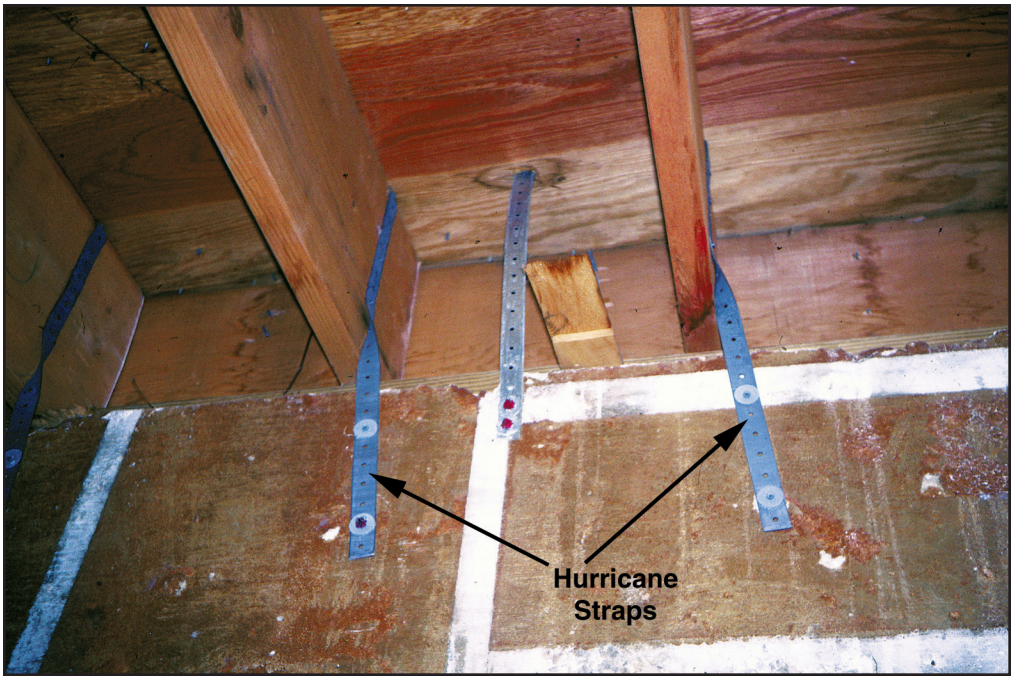
Figure 63
The new second-story walls are securely connected to the original first-floor walls with galvanized metal hurricane straps.

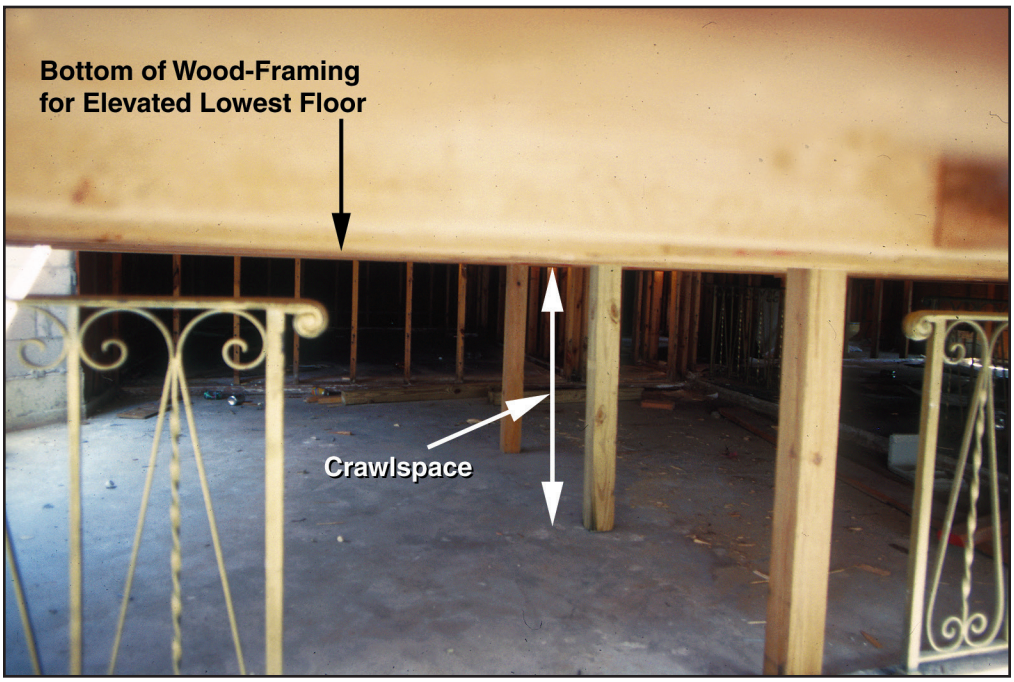
Figure 68
Rather than install a new concrete slab on compacted fill, the owner of this house chose to build a new wood-frame floor above the old concrete slab. This method creates a crawlspace below the new floor.

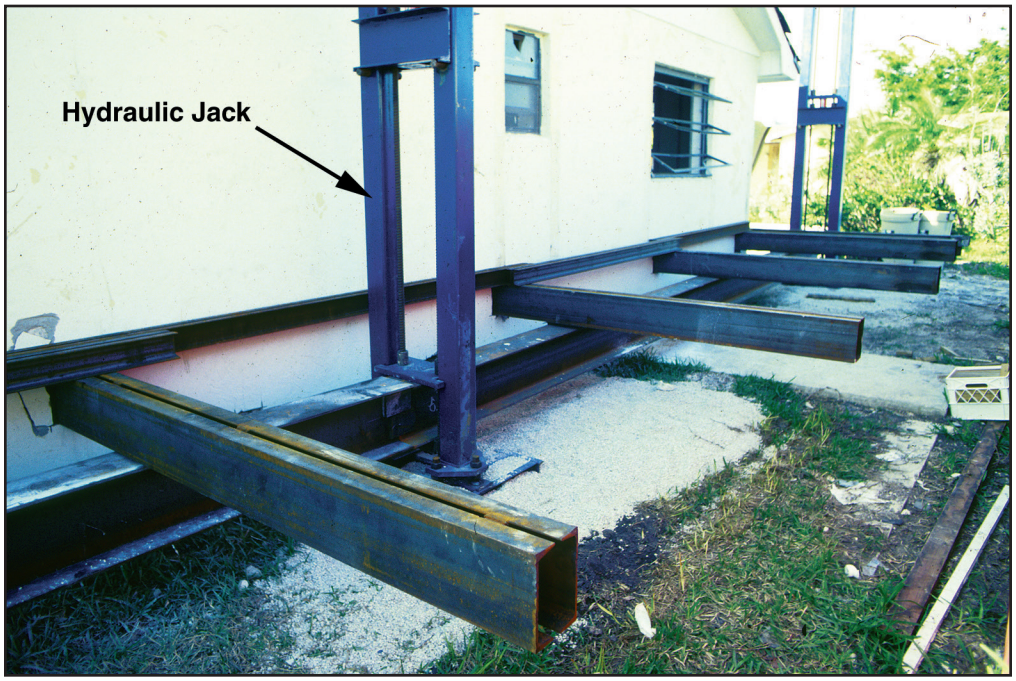
Figure 74
In this variation of Technique 3, steel beams are inserted through the walls of the house rather than under the slab. The beams span the length and width of the house and cross one another inside to create a grid. Outside the house, the beams rest on larger beams that will be raised with hydraulic jacks.

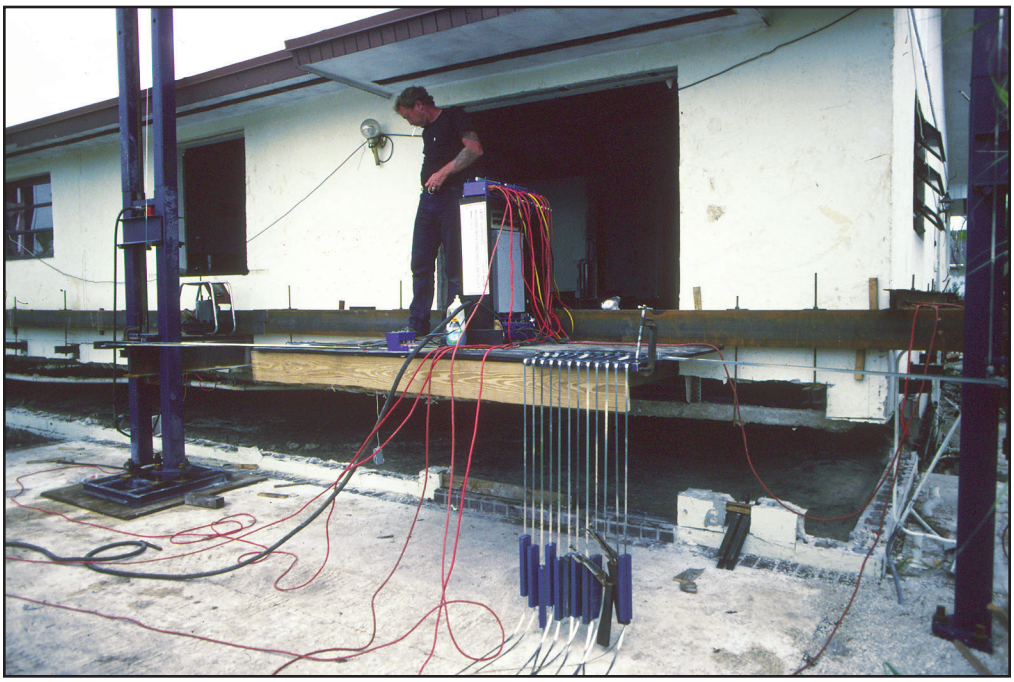
Figure 80
Lifting the house, while simple in theory, is complicated by the need to ensure an equal amount of lift at each jack throughout the process. Too much or too little lift at even one jack can cause the slab and walls to crack. The elevation contractor for this project used a sophisticated jacking system that provided the required level of control.
